**BOG BROOK DAM**

**NH 00194**

**PHASE I INSPECTION REPORT  
NATIONAL DAM INSPECTION PROGRAM**

**JULY 1980**

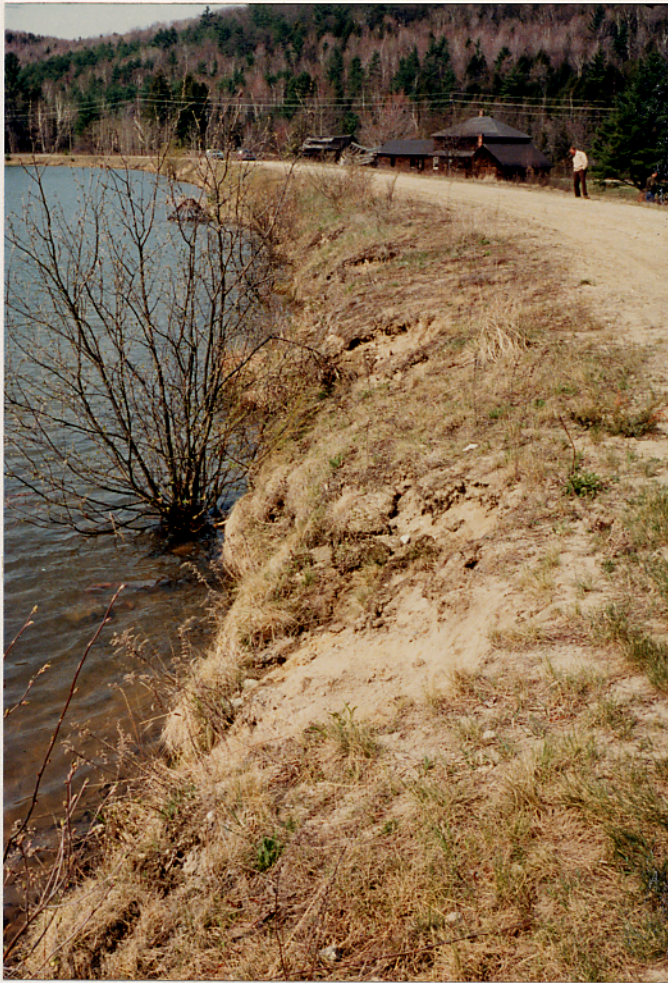
1. View of Upstream Slope Showing Sloughing and Brush Growth

It is recommended that the services of a qualified registered professional engineer be retained to investigate the condition of the upstream slope and make recommendations for the regrading of the slope and the placement of slope protection such as riprap. The owner should implement the findings of the engineering study.

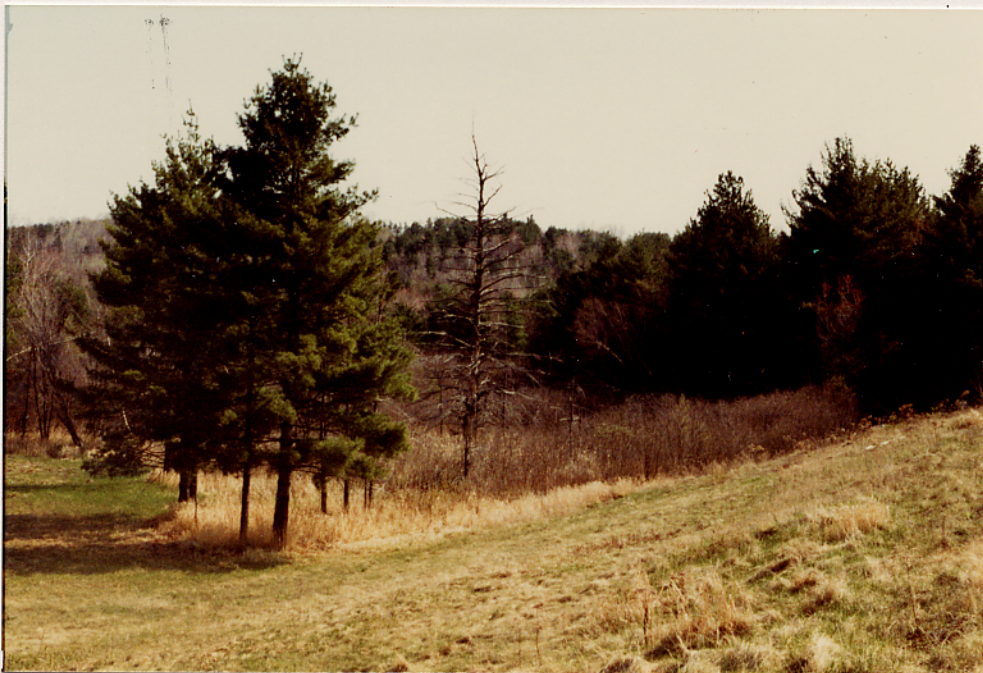
AREA EVALUATED	BY	CONDITION & REMARKS
Seepage	NAC	has ponded water. Appears to be seepage. No visible flow.
Piping or Boils	↑	None noted
Foundation Drainage Features	↓	None noted
Toe Drains	↓	None noted
Instrumentation System	NAC	None noted
<u>Drop Inlet Spillway Structure</u>		
Condition of Concrete	PR	Good
Spalling	↑	None noted
Erosion	↓	None noted
Cracking	↓	None noted
Rusting or Staining of Concrete	↓	None noted
Visible Reinforcing	↓	None noted
Efflorescence	↓	None noted
Trash Racks	↓	No deficiencies noted
<u>Reservoir Discharge Conduit</u>	↓	Submerged, could not be inspected
<u>Outlet Conduit</u>	PR	No deficiencies noted

2. View of Downstream Slope Showing Wet Area at Right Toe

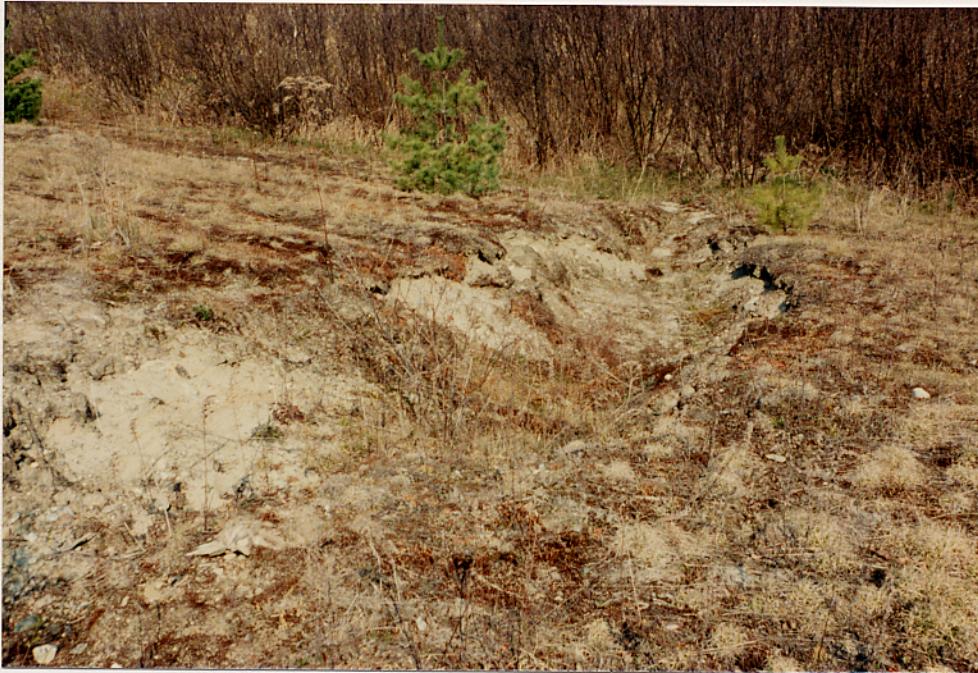
3. View of Large Erosion Gully on Downstream Slope

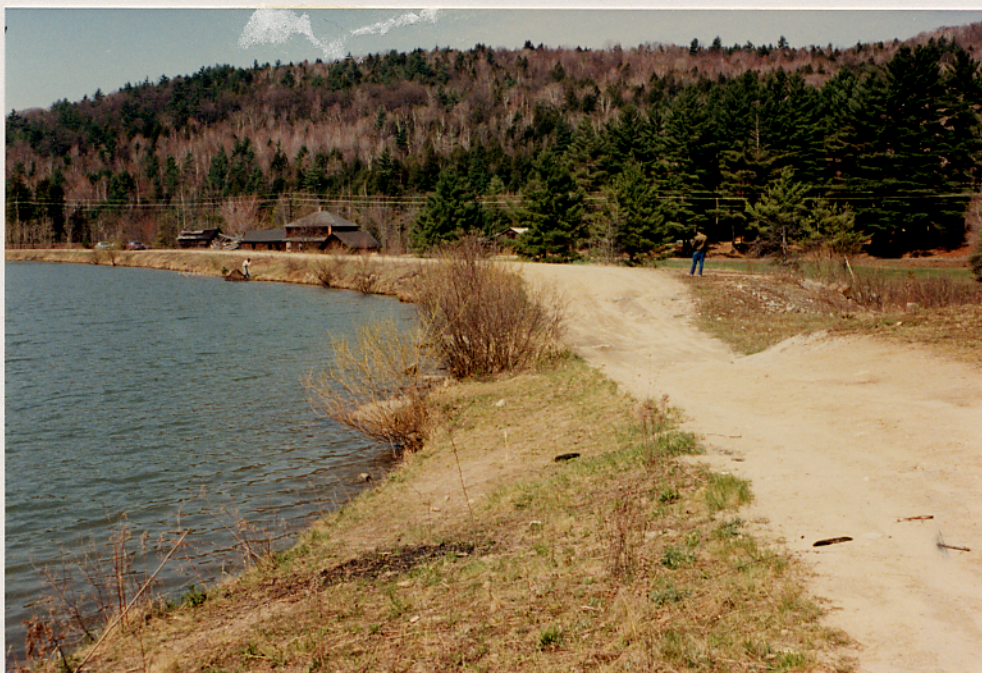
4. View from Right Abutment Showing Emergency Spillway Channel

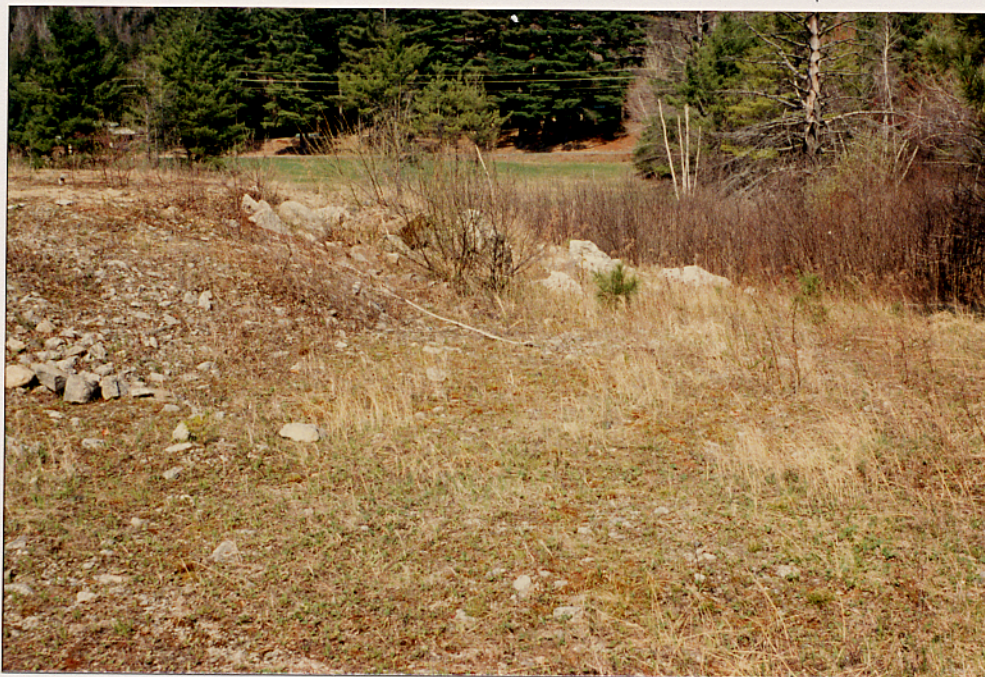
5. View of Emergency Spillway Channel Looking Downstream

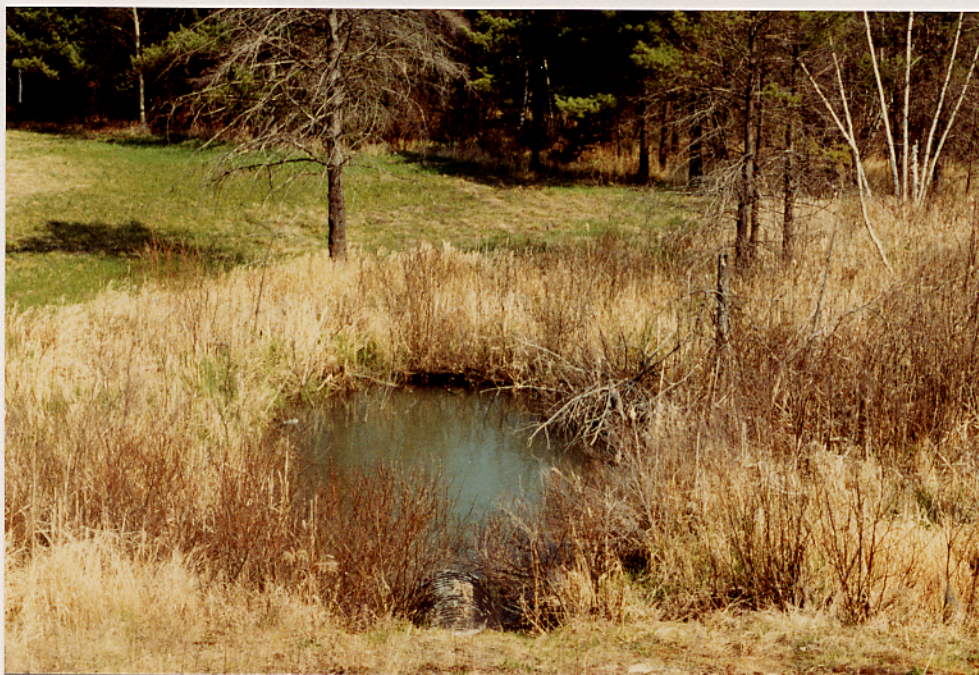
The outlet channel is a winding sluggish stream across a wide floodplain. It appears stable and in good condition.

6. View of Outlet Channel Looking Downstream

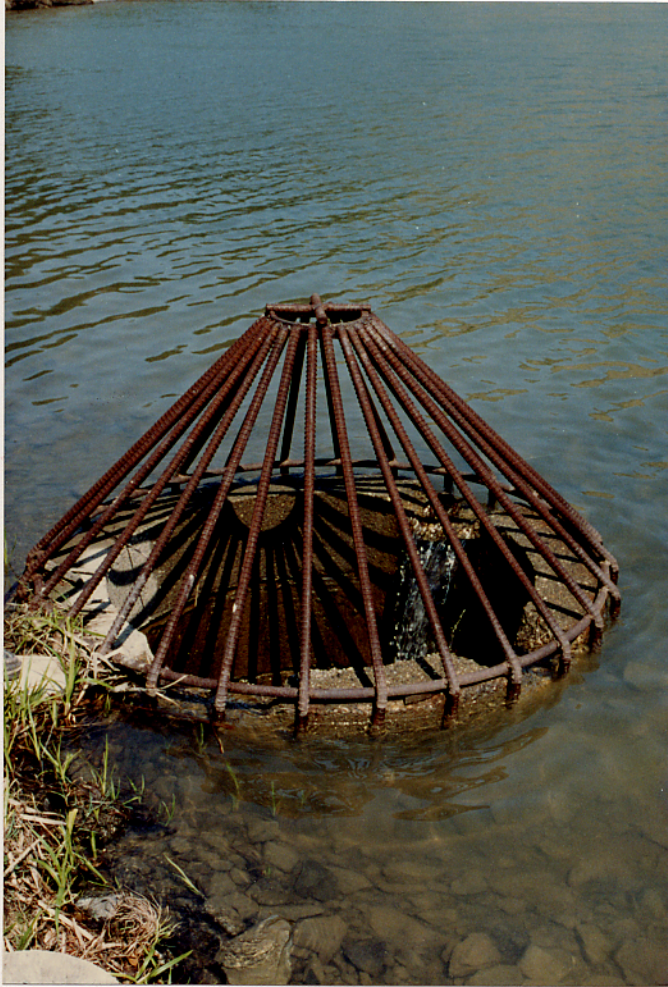
The spillway structure appears to be in good condition. The trash rack is clear of debris. The rim of the inlet has three slots, measuring approximately 6 inches deep, cut into it. These show signs of erosion.

7. Principal Spillway Inlet
